DECISION, FINDINGS OF FACT AND CONCLUSIONARY FINDINGS OF THE MCMINNVILLE HISTORIC LANDMARKS COMMITTEE FOR THE APPROVAL OF ALTERATIONS TO A HISTORIC LANDMARK LOCATED AT 835 NW BIRCH STREET

- DOCKET:** HL 3-20 (Certificate of Approval for Alteration)
- REQUEST:** Approval of alterations to an existing historic landmark and building that is listed on the McMinnville Historic Resources Inventory as a “Significant” historic resource (resource number B274). The proposed alterations include the relocation of one existing vinyl window, the addition of one new vinyl window, and the replacement of the existing asphalt composition roof with a standing seam metal roof.

- LOCATION:** 835 NW Birch Street. The property identified as Tax Lot 9300, Section 20AA, T. 4 S., R. 4 W., W.M.
- ZONING:** R-2 (Single Family Residential)

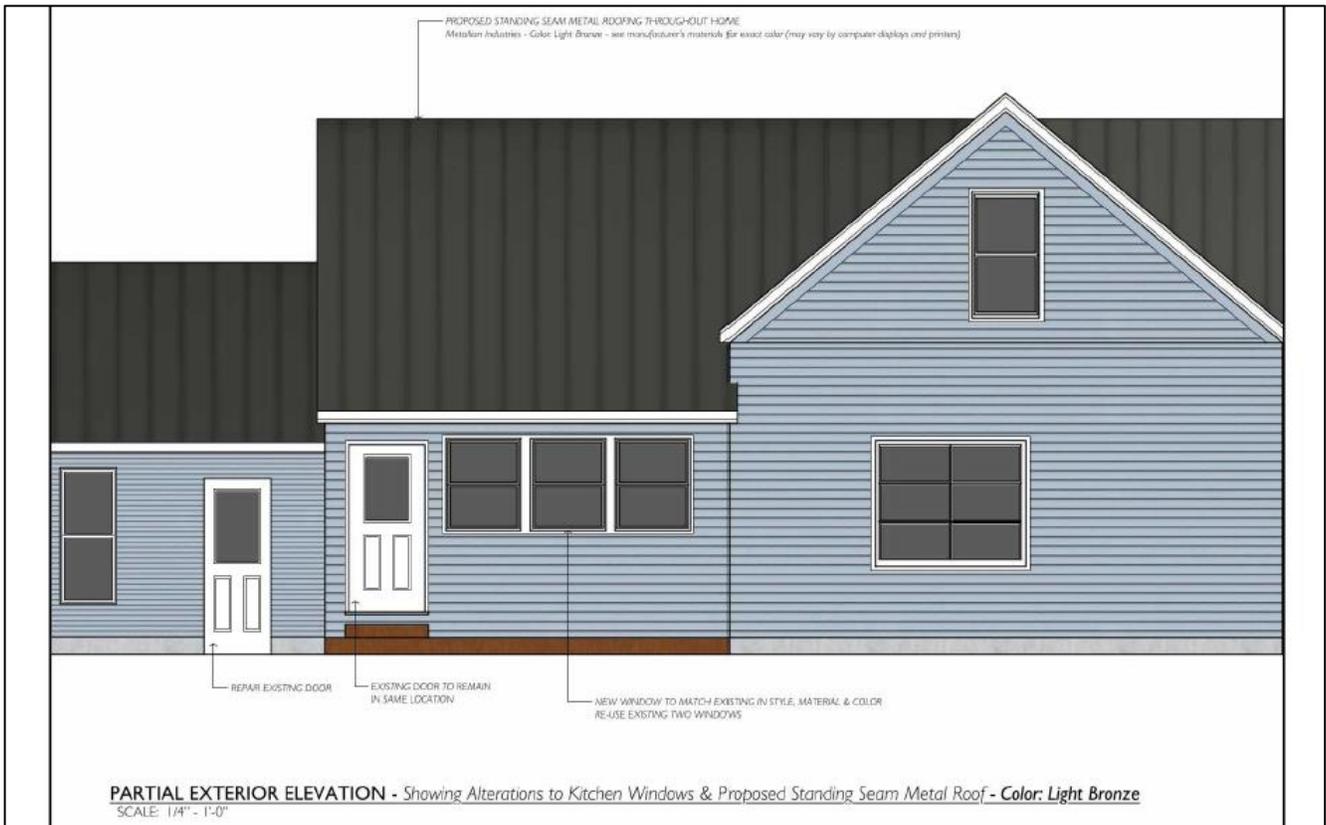
The proposed alterations are identified in the submitted south building elevation below:

“This application is for the remodel of the existing single family home located at 835 NW Birch Street. Relative to the applicable review criteria, the exterior work of the project remodel includes two elements; the relocation of one window and the addition of one new window, and re-roofing the house to replace the aging asphalt shingles with standing-seam metal roofing.

Findings for Window Alteration: The specific window alteration involves moving an existing vinyl window slightly, and installing another vinyl window immediately adjacent to it. The existing window will remain, but will be relocated. The addition of a new window in this location is not a replacement of a missing feature, but rather a new feature being installed adjacent to window features that have already been altered and replaced with vinyl window materials.

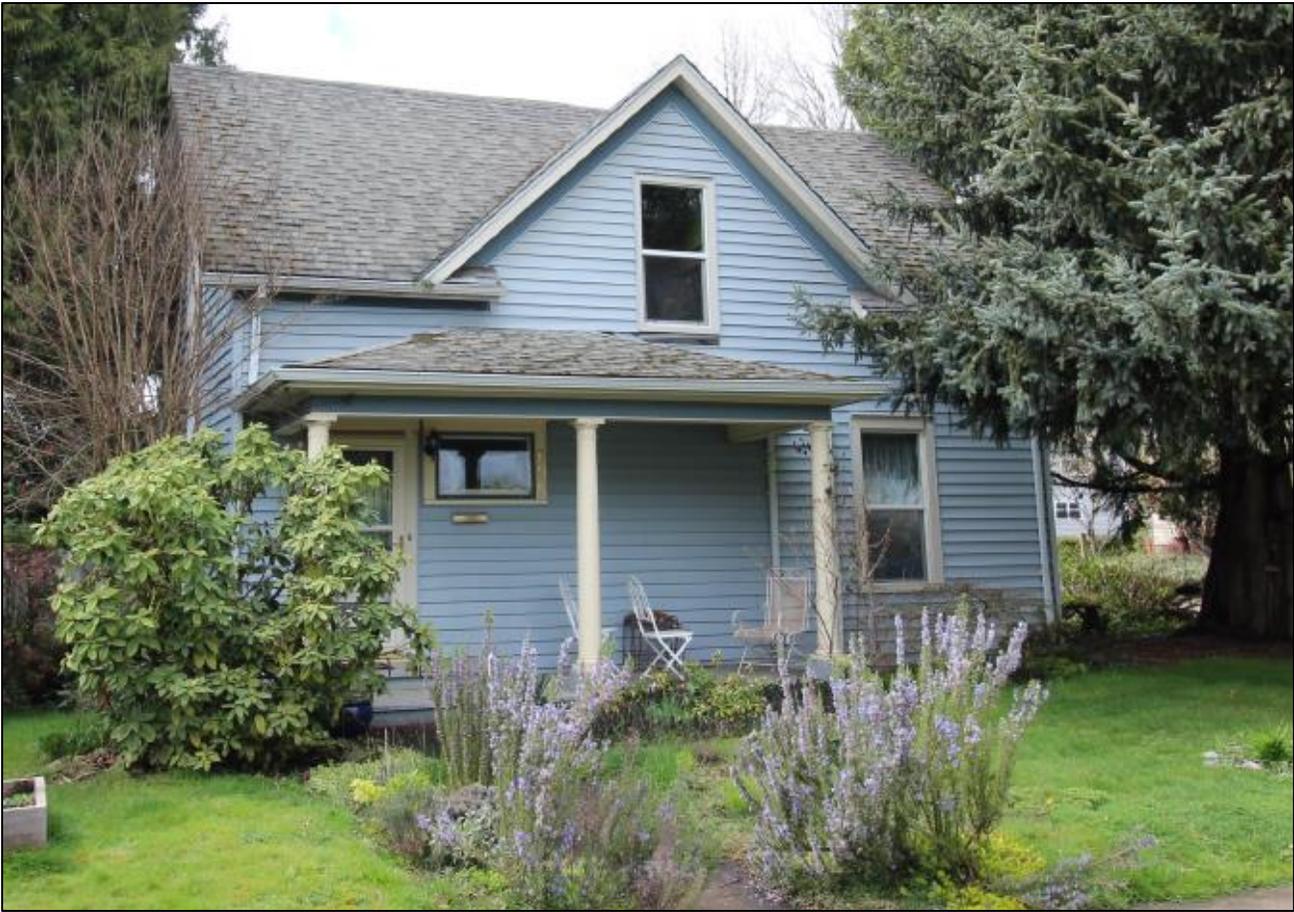
East Elevation:

The applicant has described that changes have occurred to the building since the time of the survey in 1980. The house now has an asphalt shingle roof instead of a cedar shingle roof, vinyl siding instead of beveled siding, and some white vinyl windows that appear to have replaced past windows of a different material.
